Storm Water Construction General Permit Inspection Report

RWQCB - Region 5S

WDID # 5S03C337319

Pine Grove Bluffs
Name of Development

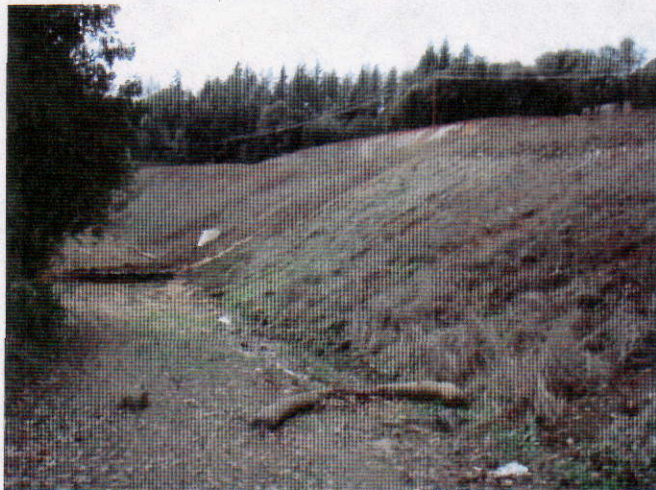
Figure 1: One of the discharge locations

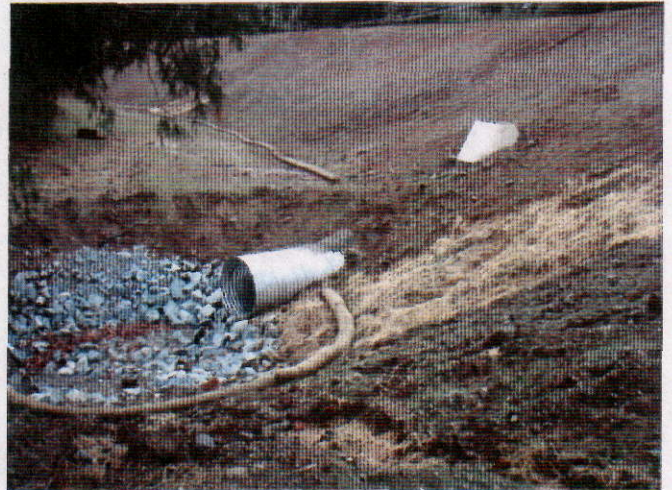
Figure 2: Poor BMPs directly around a outfall location

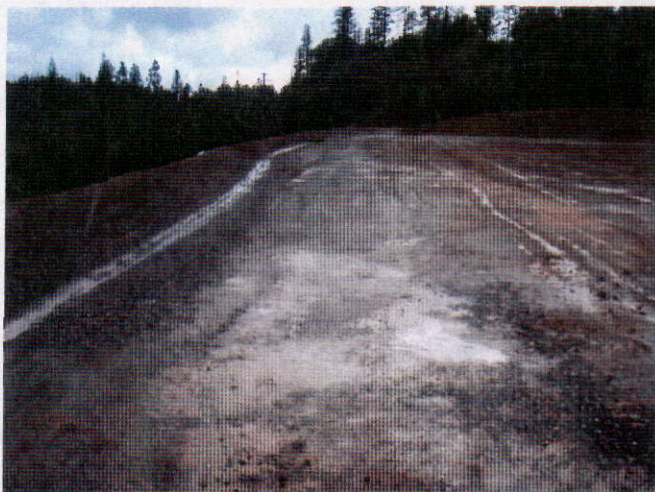
Figure 3: A portion of the site

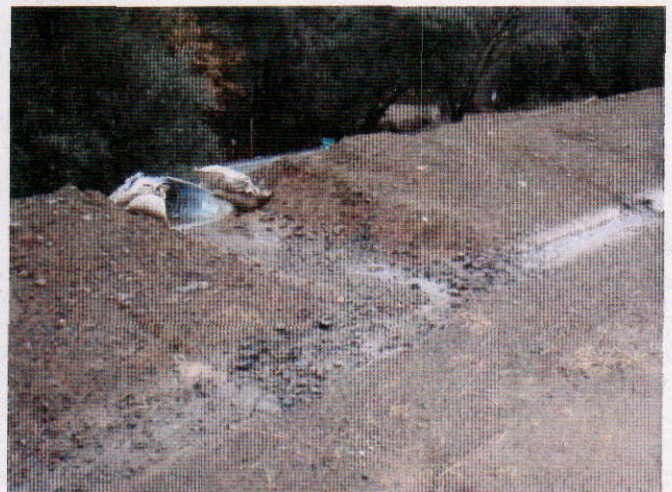
Figure 4: Poorly protected down drain inlet

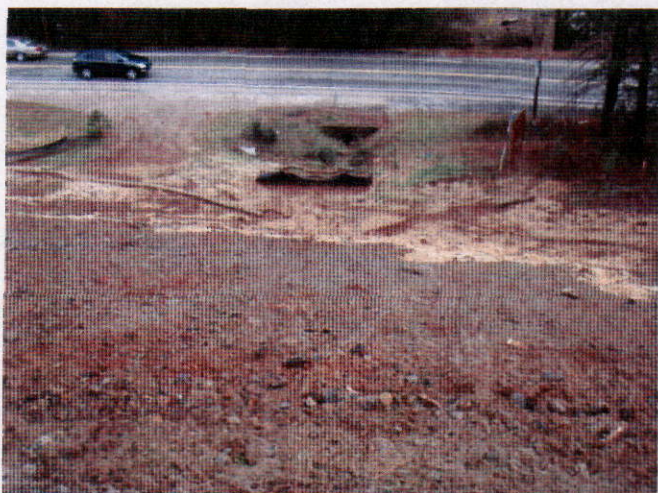
Figure 5: Rilling on the slope

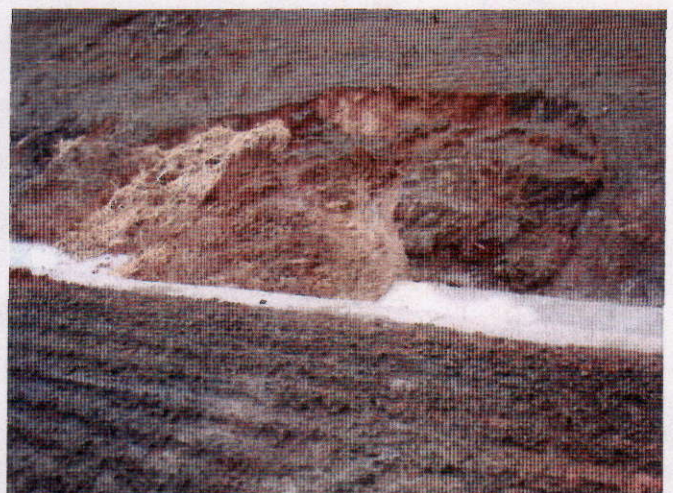
Figure 6: Slump that has deposited sediment in the concrete lined storm water conveyance system

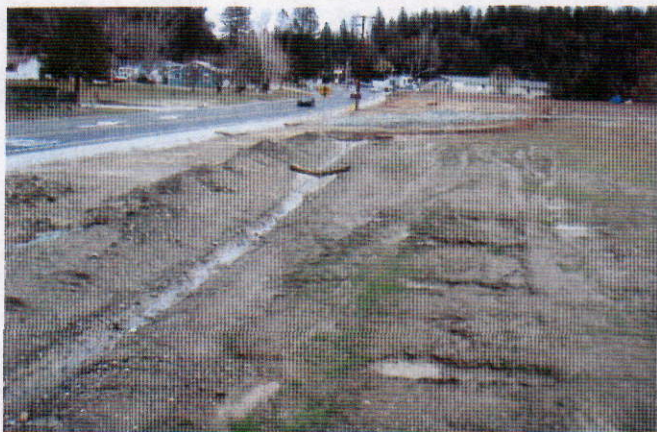
Figure 7: Poor erosion control BMPs

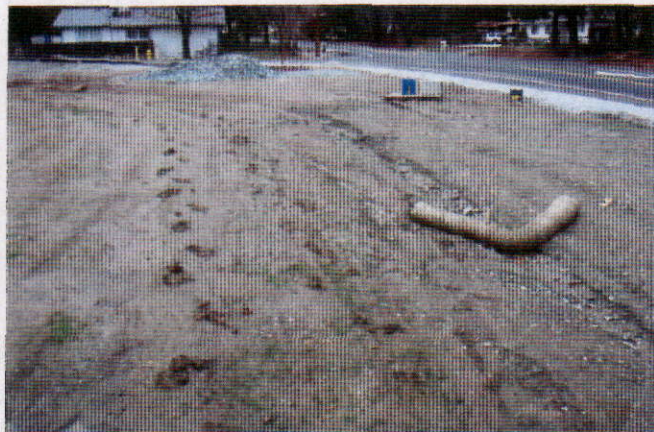
Figure 8: Another view of a portion of the project which requires additional BMPs

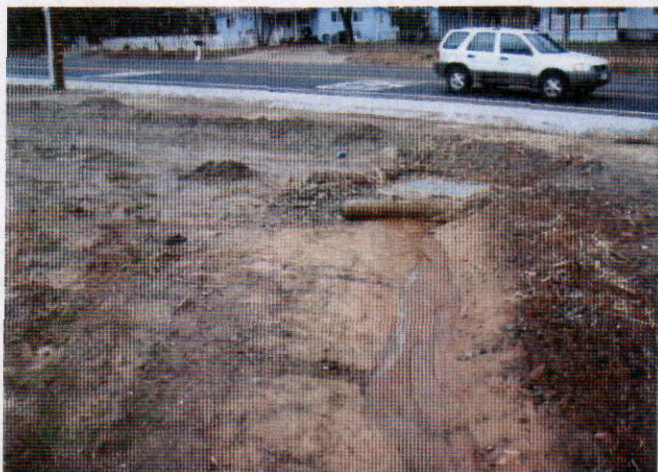
Figure 9: Poorly protected drain inlet

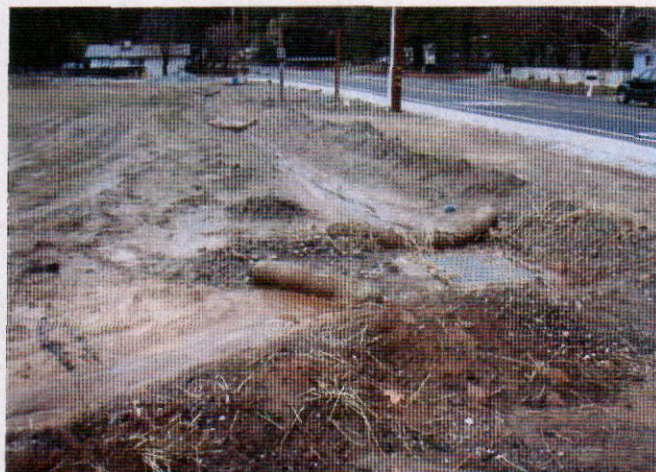
Figure 10: Another view of the protected drain inlet

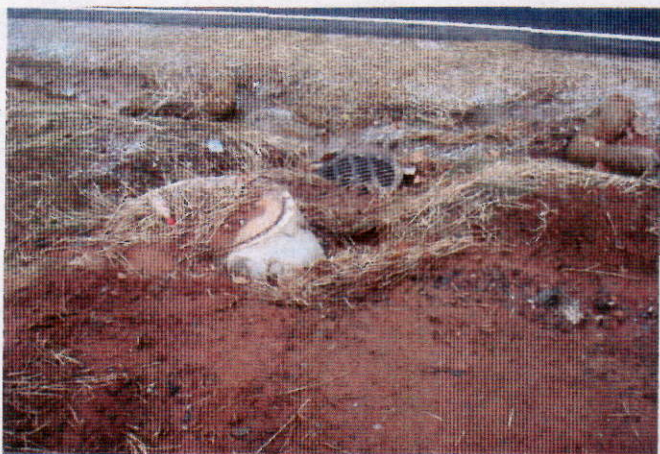
Figure 11: Another view of the protected drain inlet

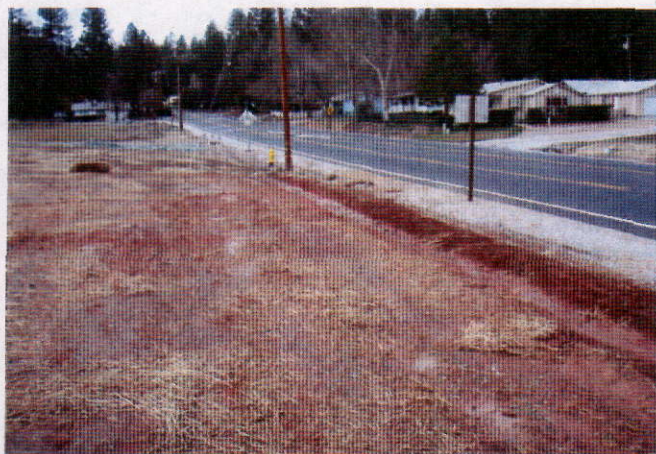
Figure 12: : Poor erosion control BMPs

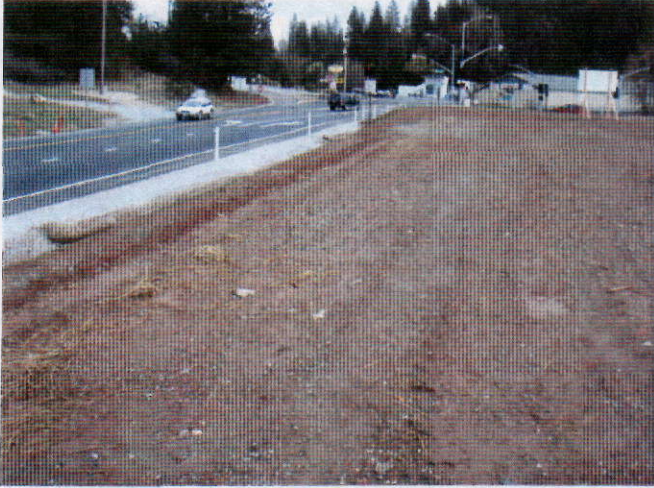
Figure 13: : Poor erosion control BMPs
